F-111C Lower Wing Skin Bonded
Composite Repair Substantiation
Testing

R. Boykett and K. Walker

DSTO-TR-0480

This report documents the results of a comprehensive testing program for the substantiation of a bonded boron epoxy patch repair to a fatigue crack in the lower wing skin of an F-111C aircraft (A8-145) in the Royal Australian Air Force. The fatigue crack was a chordwise 48 mm crack in the critical, non-failsafe, port lower wing skin at approximately 2/3 semi span. The crack had reduced the wing's residual strength to below Design Limit Load and the repair was therefore critical; the options were to scrap the whole wing or apply a bonded repair. This repair represents the most critical application of bonded repair technology yet undertaken anywhere in the world.

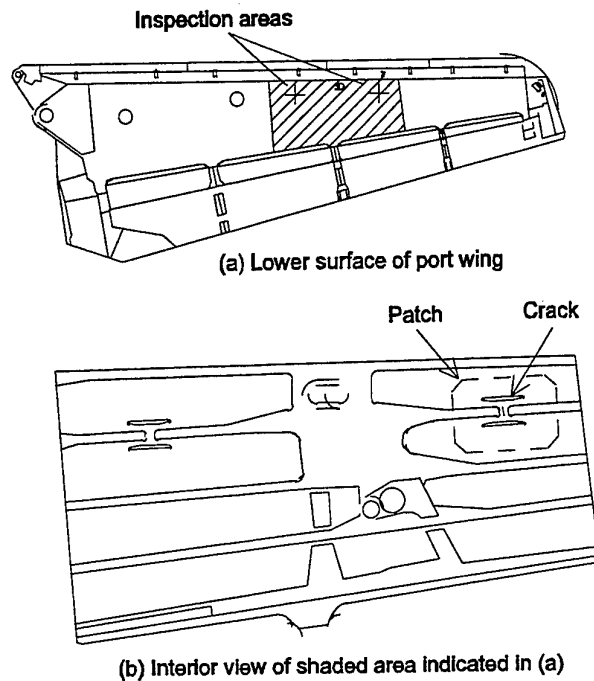
A crack was discovered in the port lower wing skin of a Royal Australian Air Force F-111C aircraft (RAAF tail number A8-145) during a routine visual inspection. The initial indication was fuel seepage at the site of an apparent 40 mm chordwise crack; however, a detailed non-destructive inspection revealed a through-thickness crack, 48 mm long tip-to-tip. Fracture mechanics calculations indicated that the residual strength had been degraded to 150 MPa (21.7 ksi), which is considerably less than the Design Limit Stress of 256 MPa (37.1 ksi) specified for this region of the wing¹, compromising flight safety.

Figure 1 indicates the location of cracking on the lower wing-skin. Raised portions serve as integral stiffeners and as attachment lands for spars. The cracking occurred in an area lying below the forward auxiliary spar, at the spar station FASS 281.28, where the thickness of the integral stiffener is reduced from approximately 8.2 mm to the nominal skin thickness (3.7 ± 0.1 mm at this location). The purpose of this depression in the stiffener is to allow full fuel flow and drainage between adjacent bays of the

Figure 1. Crack location on the F-111C lower wing-skin and repair patch outline.

A mechanically fastened metallic doubler repair option was rejected for a range of reasons, including undesirable aerodynamic implications and because the underlying structure could not be inspected. The only viable alternative to scrapping the wing was a bonded repair. A bonded boron fibre epoxy repair was designed and implemented by RAAF personnel, on the basis of design principles and application procedures developed by DSTO,^{2,3} now incorporated by the RAAF into an Engineering Standard (C5033)⁴. Because the repair is to primary structure, comprehensive substantiation is needed to certify its airworthiness; Aeronautical and Maritime Research Laboratory (AMRL) is responsible for an independent validation of the repair design through Finite Element Modelling (FEM) and substantiation of the repair through representative specimen testing.

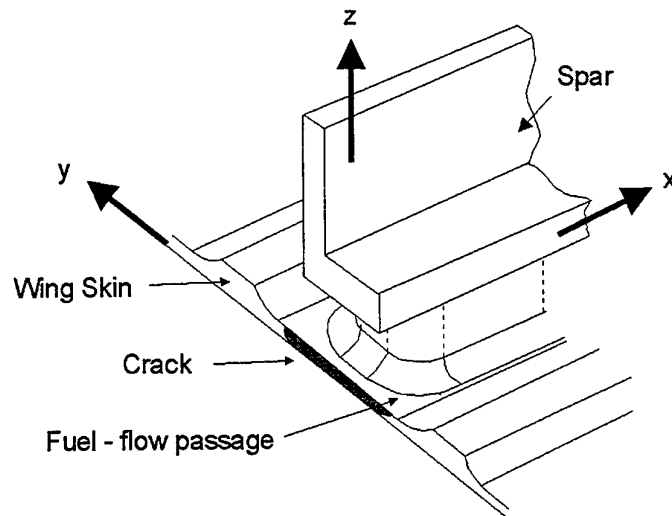
The cracking occurs in the chordwise direction, normal to the direction of the nominal principal stress from wing bending at that location. The presence of secondary bending loads results in the crack initially growing from the inside surface towards the outside surface with faster crack growth along the wing-skin's inner surface relative to its outer surface. This effect is clearly visible in the USAF specimen (refer to section 6). The discrepancy between the surface traces is further accentuated by the residual compressive stress at the outer surface caused by shot peening. For the purposes of assessing the residual strength, however, it is convenient to assume a straight-fronted through-crack, as indicated by the shaded area in Figure 2. This leads to the residual strength estimate of 150 Mpa.

Figure 2: Local geometry of the lower wing skin in the vicinity of the fuel-flow passage, showing the location of cracking and the coordinate axes used in the text.

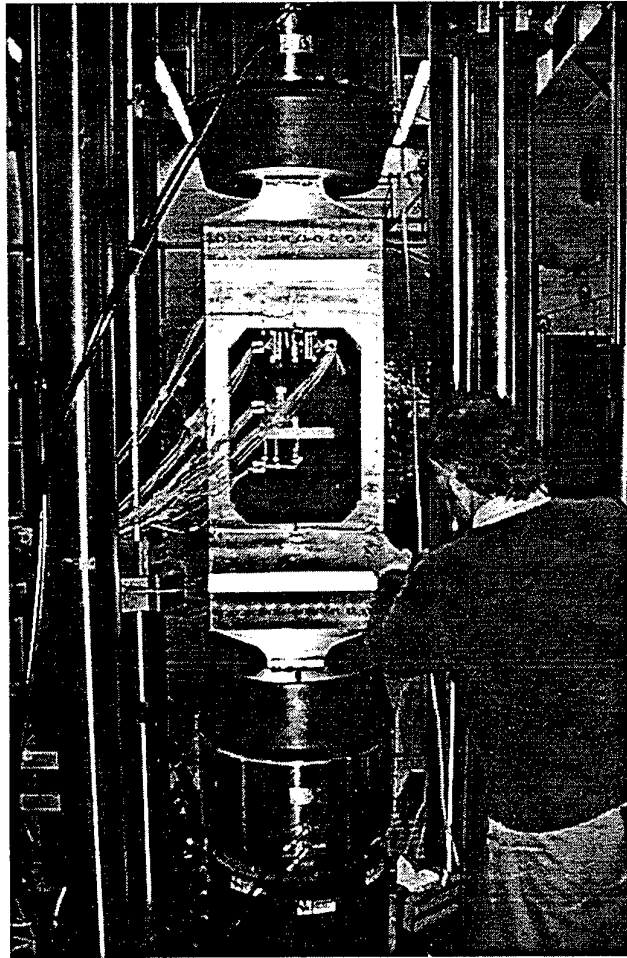
Figure 21. View onto side 1 of second box specimen in 2 MN testing machine showing strain gauge array and fracture line below end of patch.

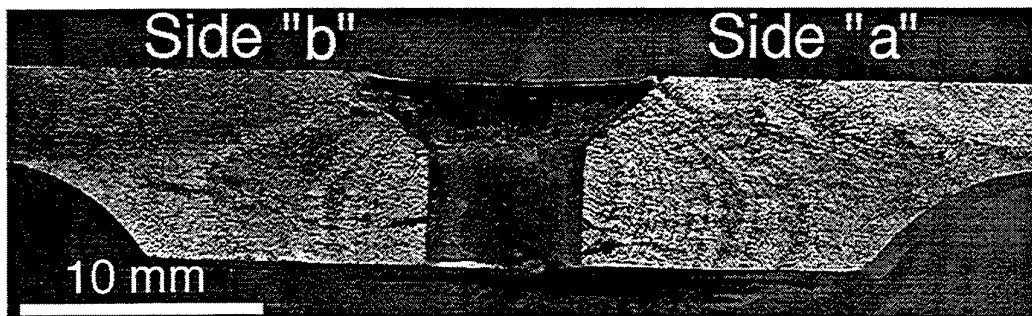
Under cyclic loading, there were two failures (one in panel *FLTP27-9* and one in the first box specimen) at the fastener hole immediately outside the end of the repair patch. Both were cyclic loaded under the blocked fatigue spectrum and both had clearance fit fasteners installed. The fracture surface of the box specimen is shown below in Figure 22 (the fracture surface of the panel is similar). The geometry of this part of the box specimen is similar to the repaired aircraft A8-145 - the patch terminates 10 mm from the centre of a 6.25 mm (nominal 0.25 inch) diameter, 100° countersunk, fastener hole. Note that there are different fasteners used ; clearance fit on the first box specimen and all the panel specimens, and interference fit on the second box specimen and the aircraft. The second box specimen also failed at this region during a static test to failure but there was no evidence of a fatigue crack initiating from any holes.

Figure 22. View onto fracture surface of first box specimen

Fatigue crack growth is clearly visible emanating from the bore of the fastener hole. A clearance fit fastener was used at this location and there is residual adhesive remaining in the bore (the fasteners were intentionally bonded in position). The crack proceeded to failure before it progressed past the end of the countersink. It was not detectable prior to failure, even with 45 degree angled eddy-current probe techniques. Similar sized cracks were evident at the other three similar fastener locations after the fasteners had been removed.

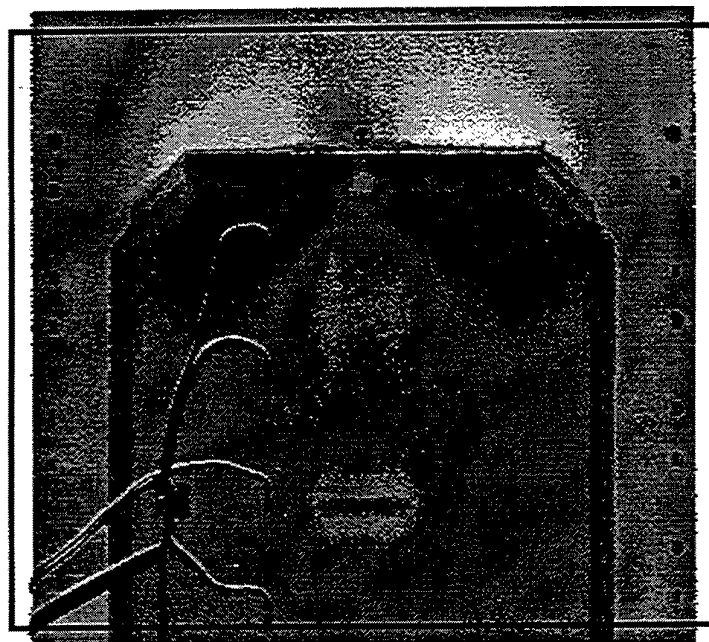
Figure 23. FAST scan - View onto Box 1, skin 2 repair patch after 800 equivalent flight hours. Spanwise load axis is vertical in this view. Lighter shaded areas have higher levels of surface strain.

The increased strains are clearly evident in the central region in the lower part of this view, where the crack location is shown by the darker line. The fastener location adjacent to the end of the patch is in an area of unusual strain distribution ; a small

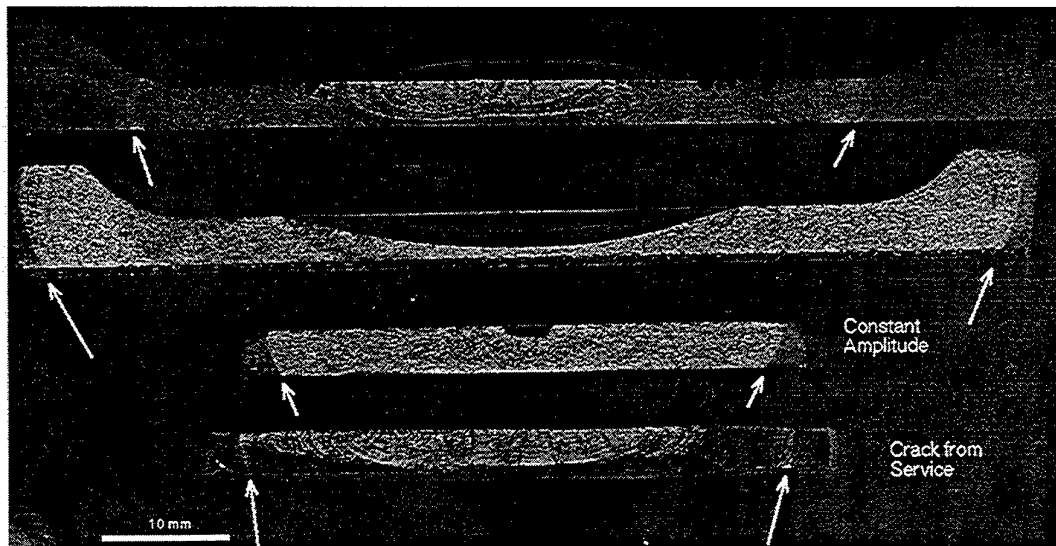
A comparison of the fracture surface of the USAF specimen and three of the AMRL panel specimens is shown in Figure 24. The crack front can be clearly seen growing from multiple initiations on the inner surface which join into a semi-circular crack. After breaking through the outer surface it becomes a through crack approximately 40 mm long. A replica of the final through crack can be obtained in test specimens by the introduction of a semi-circular EDM notch followed by constant amplitude cyclic tension loading. The multiple initiations for the crack were evident in panel specimens, that had no EDM notch, loaded under the cycle-by-cycle spectrum¹⁹.

Figure 24. Fracture surfaces (from top down)

- Panel specimen with no crack initiation, under cycle-by-cycle spectrum to failure.
- Panel specimen with large EDM notch, constant amplitude to 40 mm, then patched before failure under cycle-by-cycle spectrum.
- Panel specimen with small EDM notch, constant amplitude loading to 40 mm, then static load to failure.
- USAF fleet wing specimen (approximately 40 mm tip-to-tip).

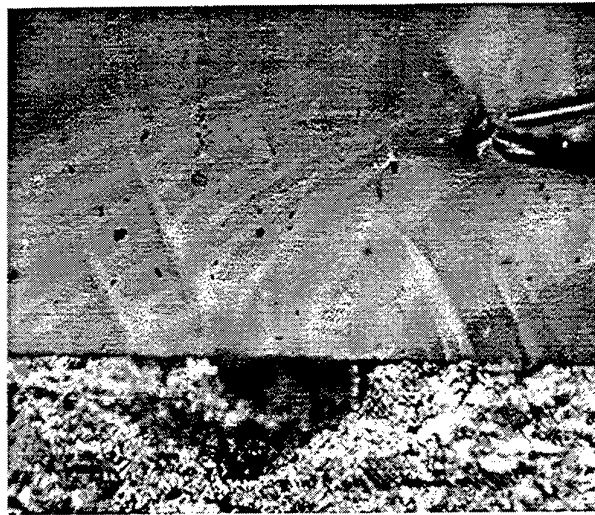
The fracture mode of panel specimens was often a clean fracture of the repair patch (no delamination) adjacent to the fracture in the aluminium adherend. Fractography shows crack growth in the adhesive very similar to that in the aluminium adherend (in Figure 25 below), but cannot determine what the failure sequence is between fibre fracture, adhesive disbonding/fracture, and cracking in the aluminium adherend. It is proposed that the crack growth in the aluminium matches that in the adhesive, since the final fracture tear begins at exactly the same place in both materials²².

Figure 25. Crack growth in adhesive layer.
